Situation Photo Log

Friday, February 1, 2013

Kalamazoo River / Enbridge Spill

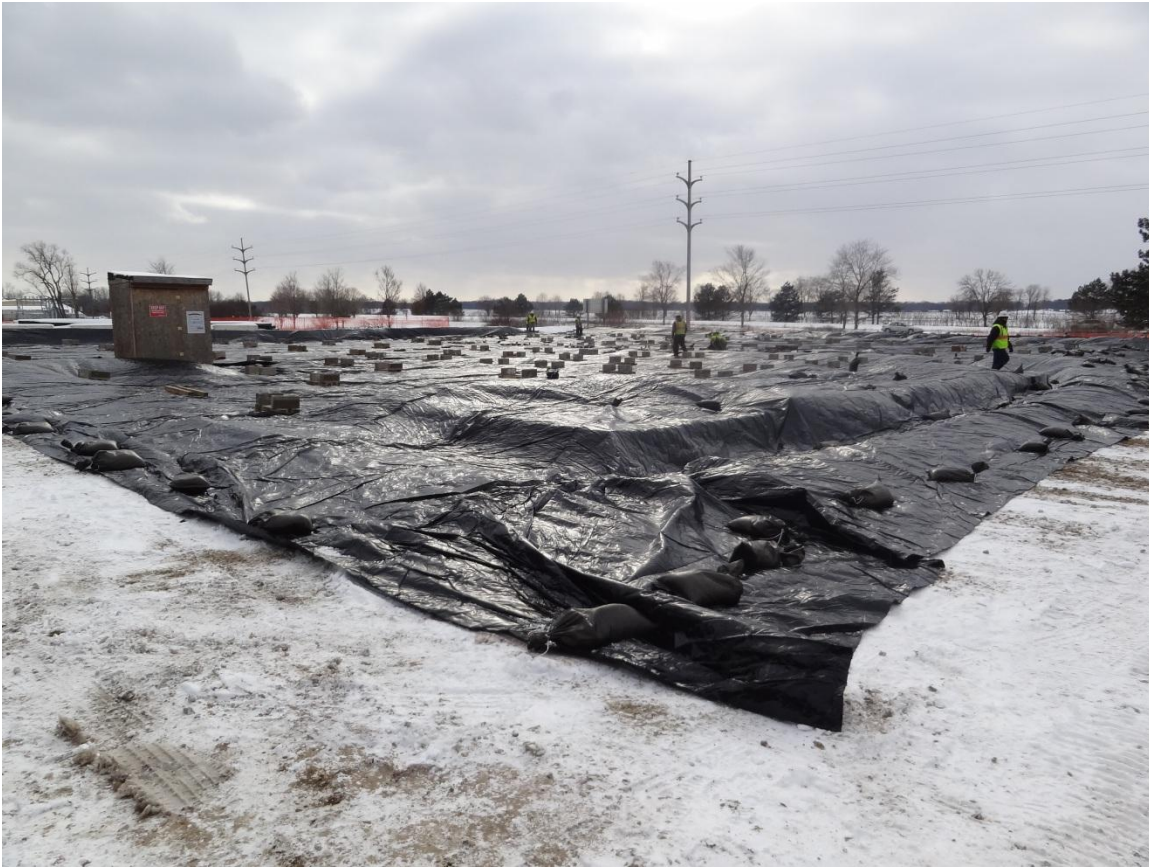
1. Frac Tank City observed securing of poly sheeting.

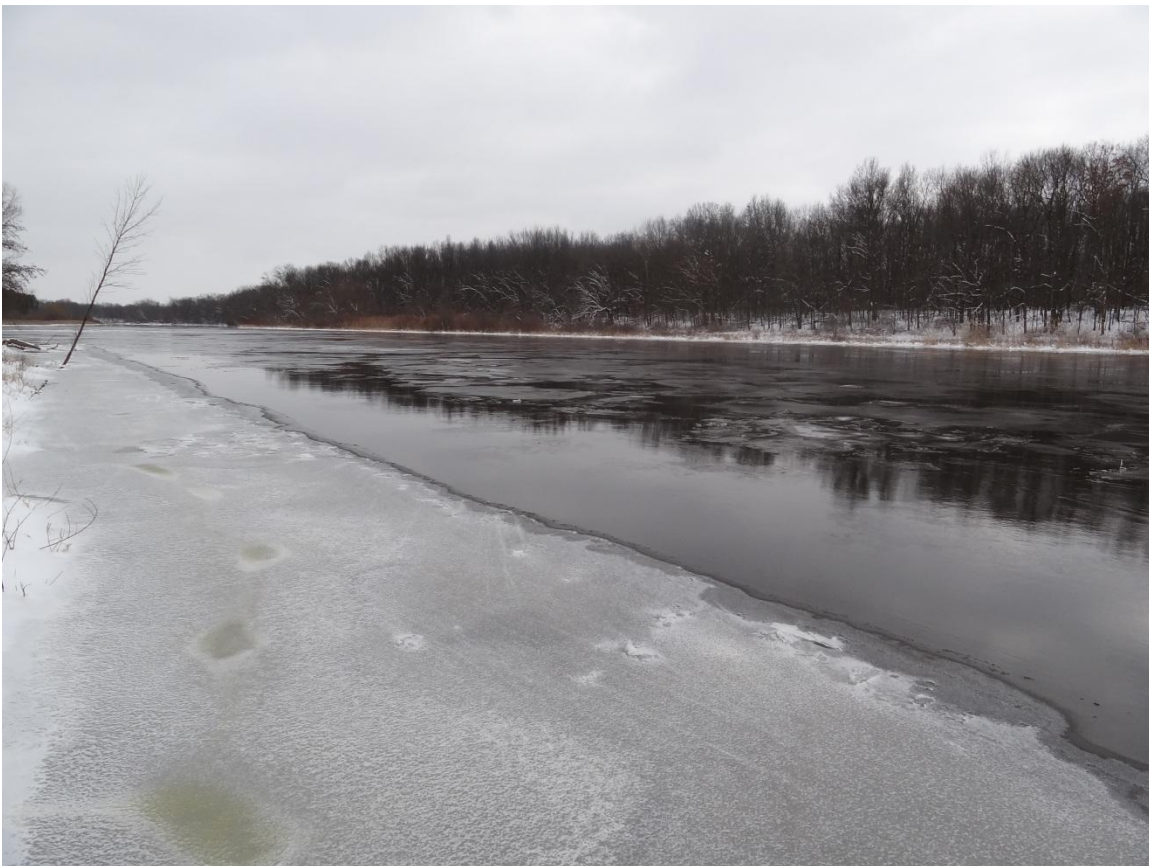
2. C0.4 Boat Launch observed upstream river icing conditions.

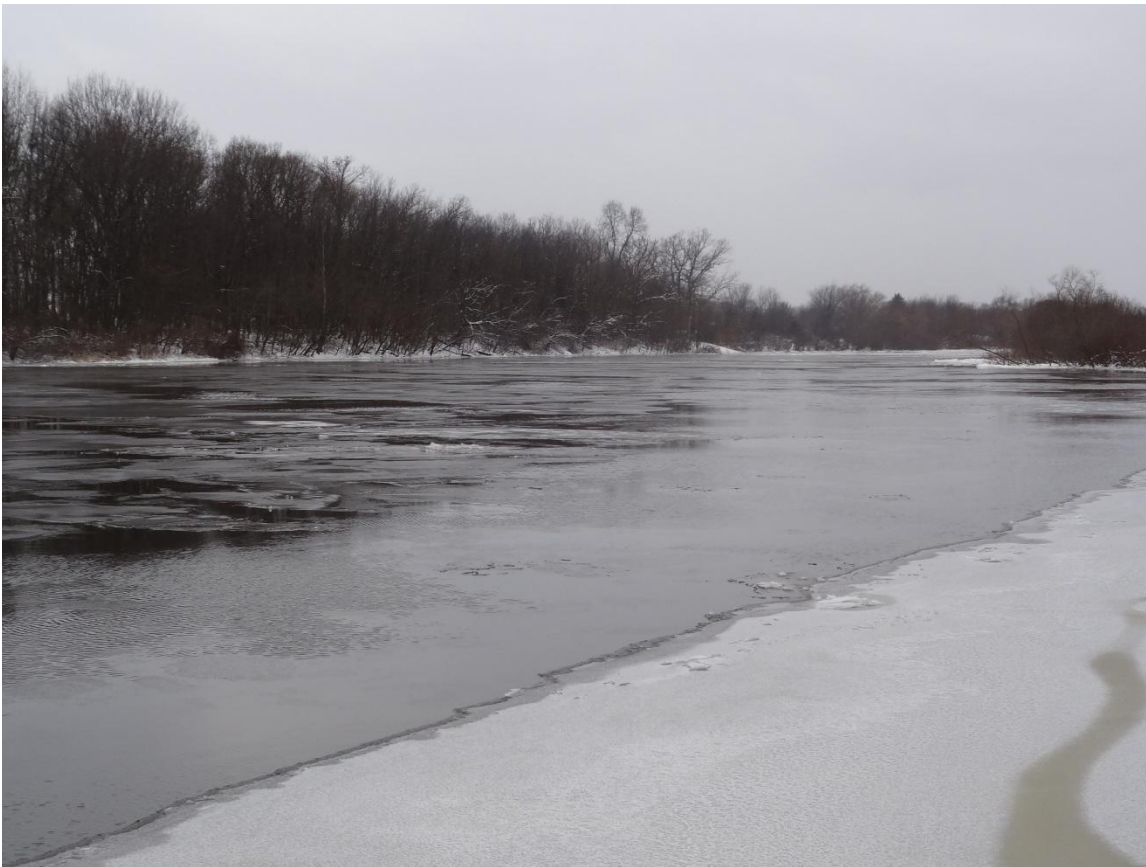
3. C0.4 Boat Launch observed downstream river icing conditions.

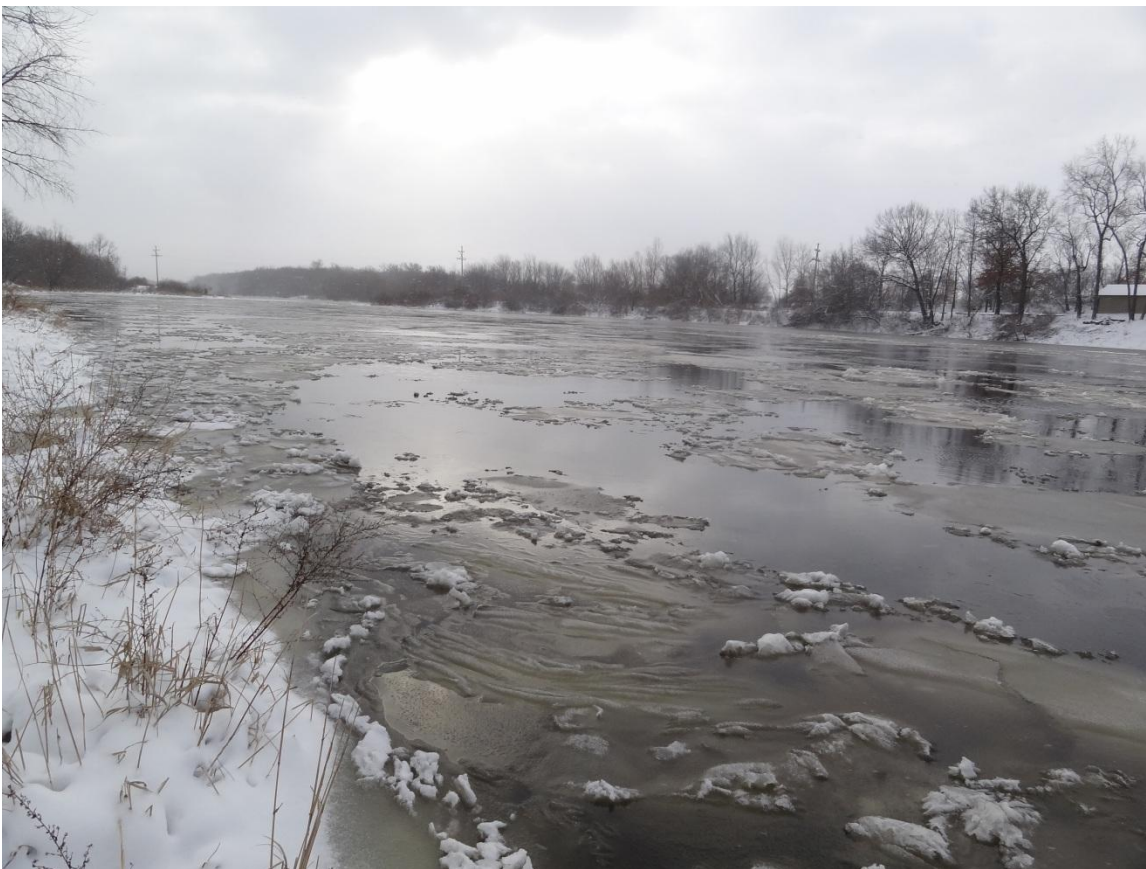
4. Ceresco Dam impoundment observed upstream river icing conditions.

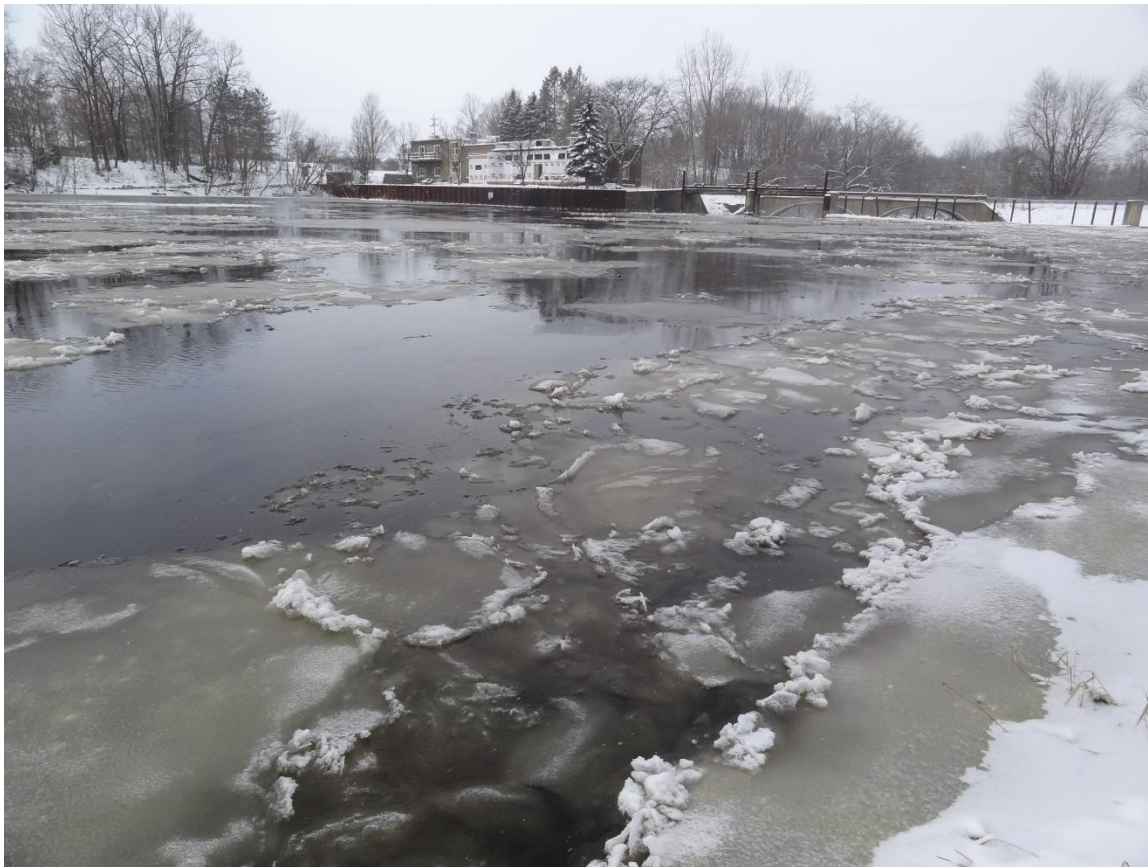
5. Ceresco Dam impoundment observed downstream river icing conditions.

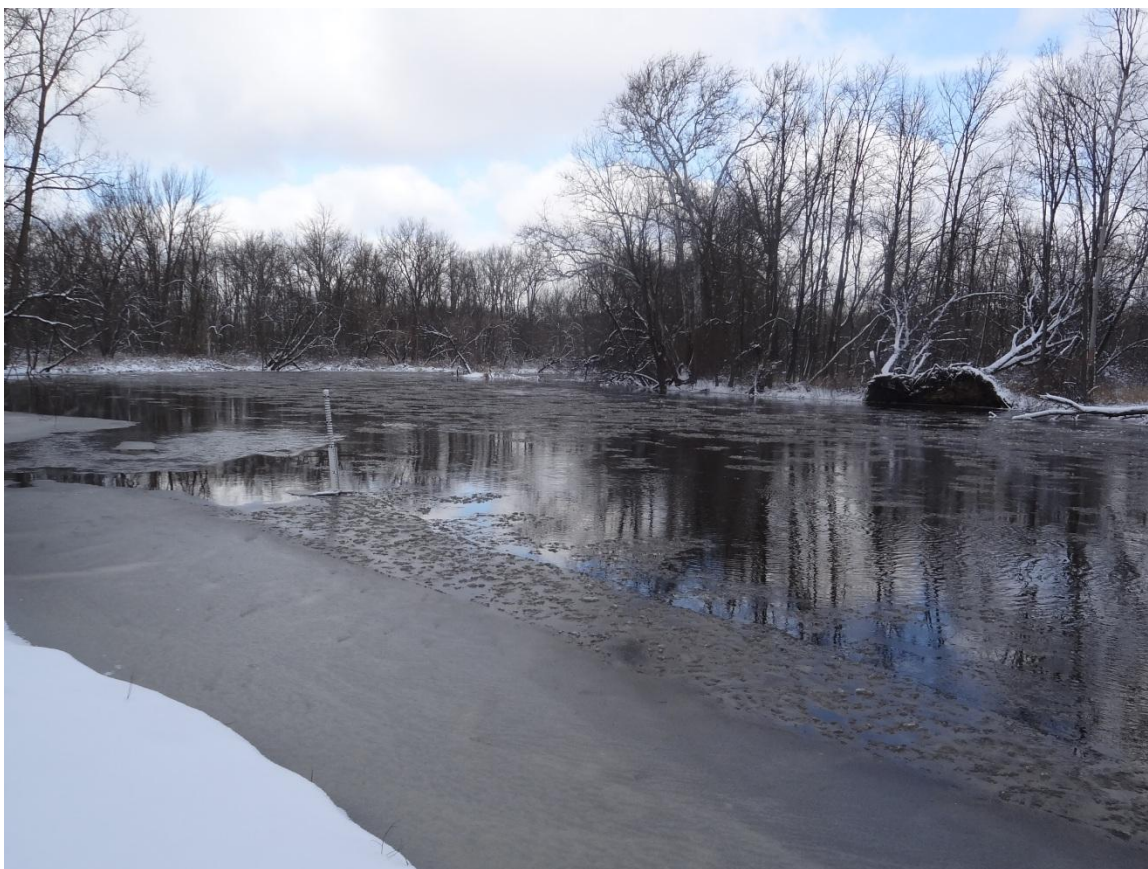
6. C3.2 Boat Launch observed river icing conditions.

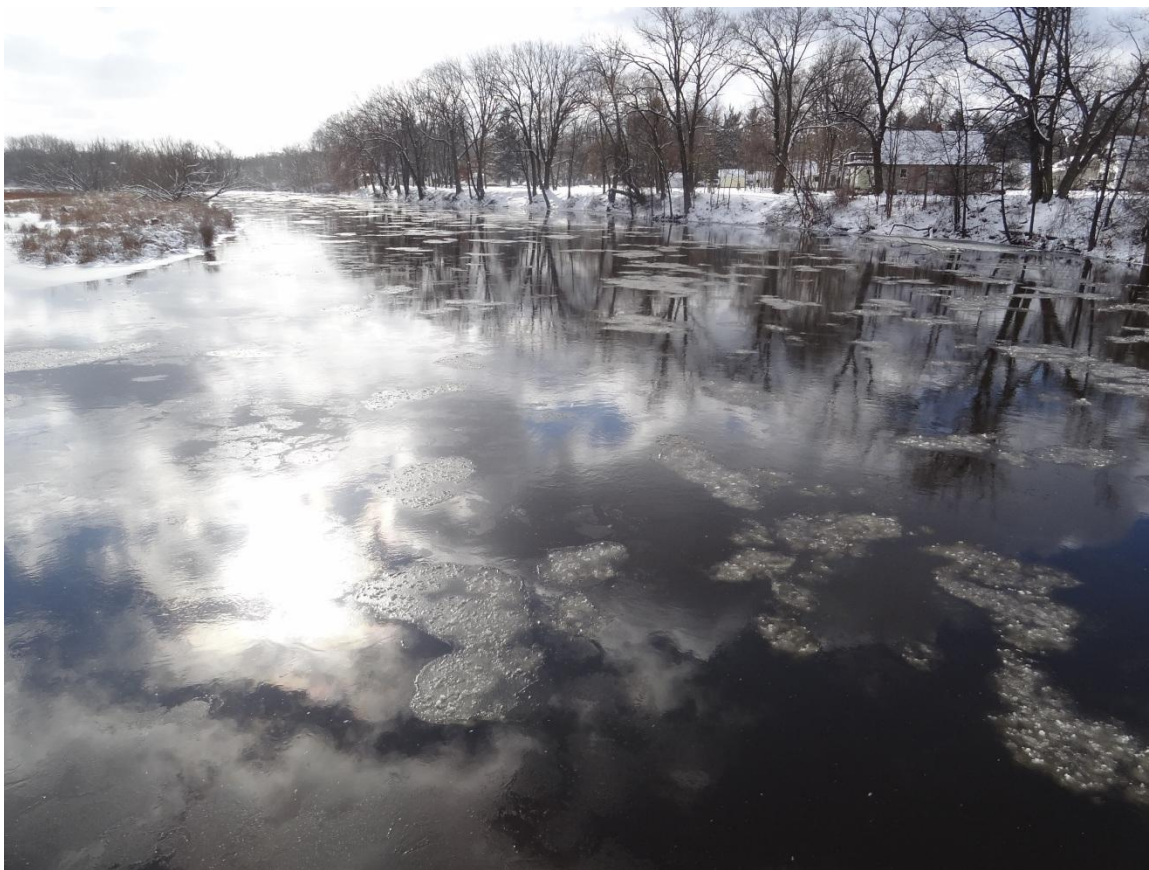
7. MP15.25 South Mill Pond observed river icing conditions.

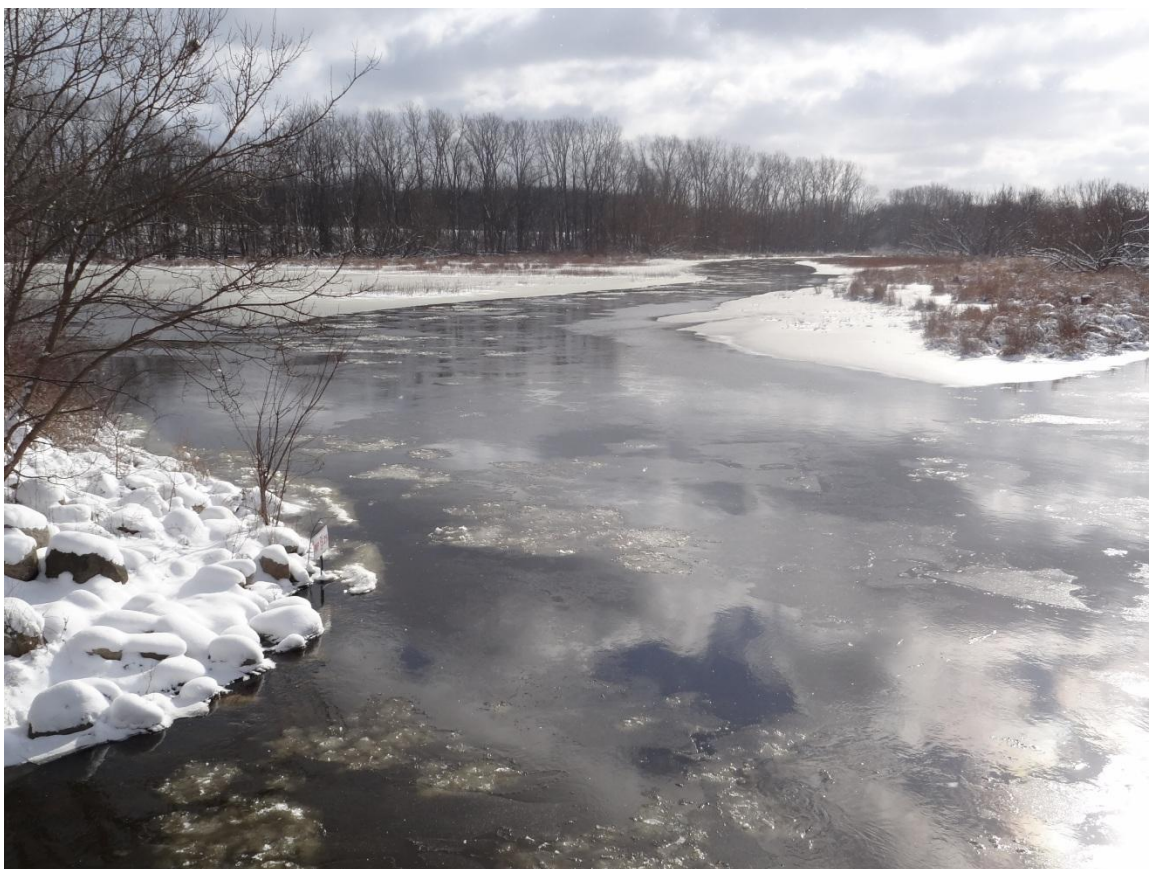
8. MP15.25 South Mill Pond observed back water icing conditions.

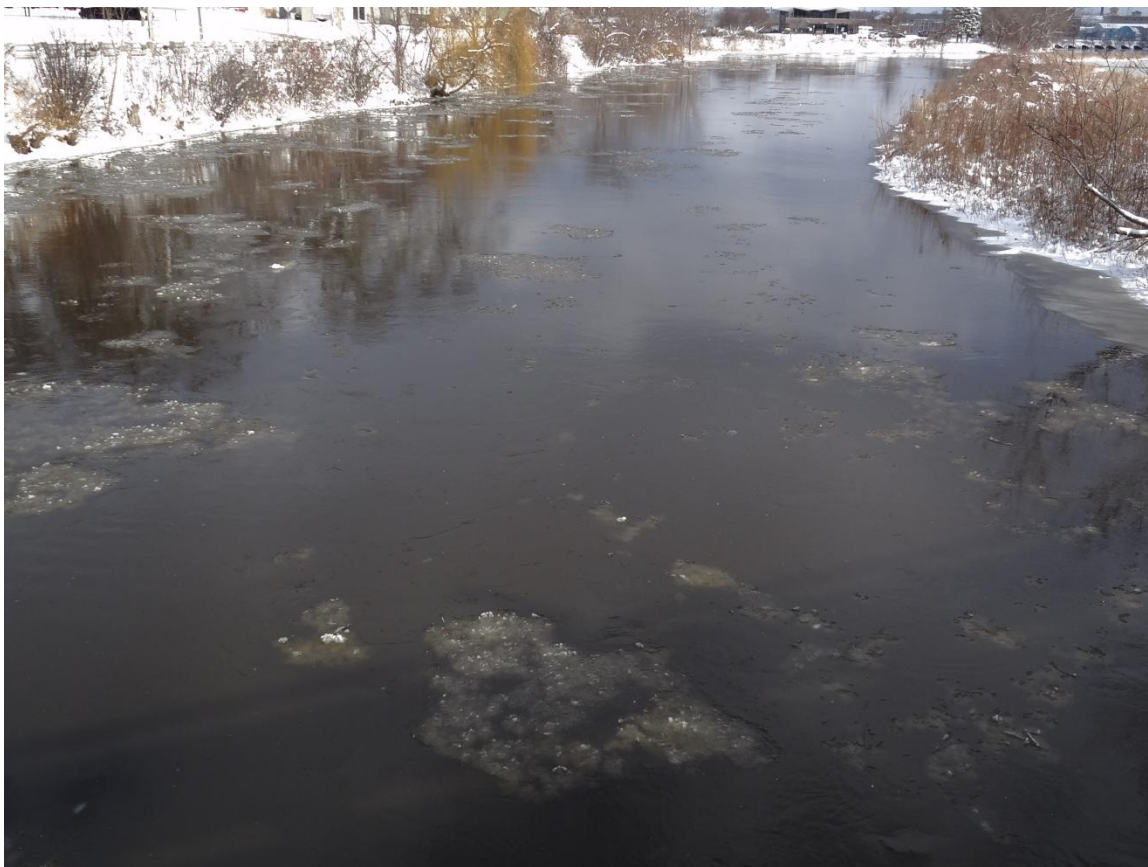
9. MP15.50 North Mill Pond observed river icing conditions.

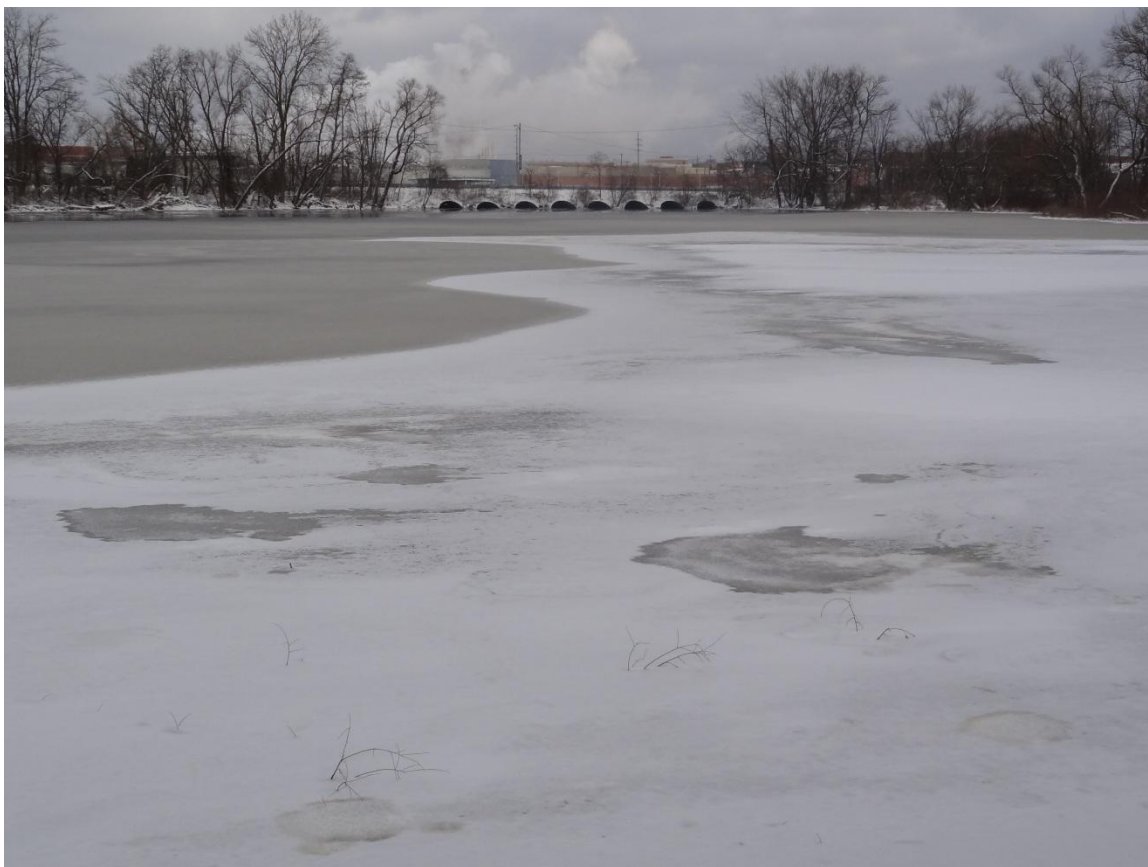
10. MP15.50 North Mill Pond observed back water icing conditions.

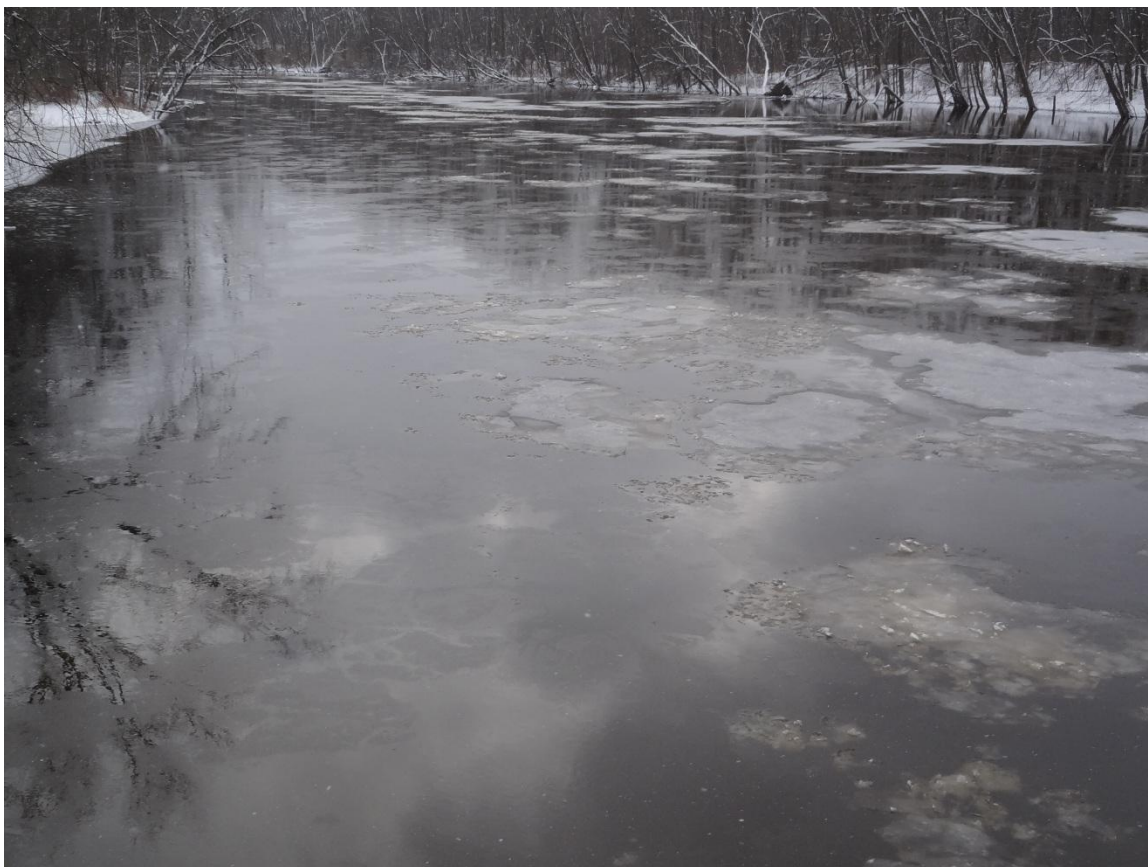
11. MP21.50 observed upstream river icing conditions.

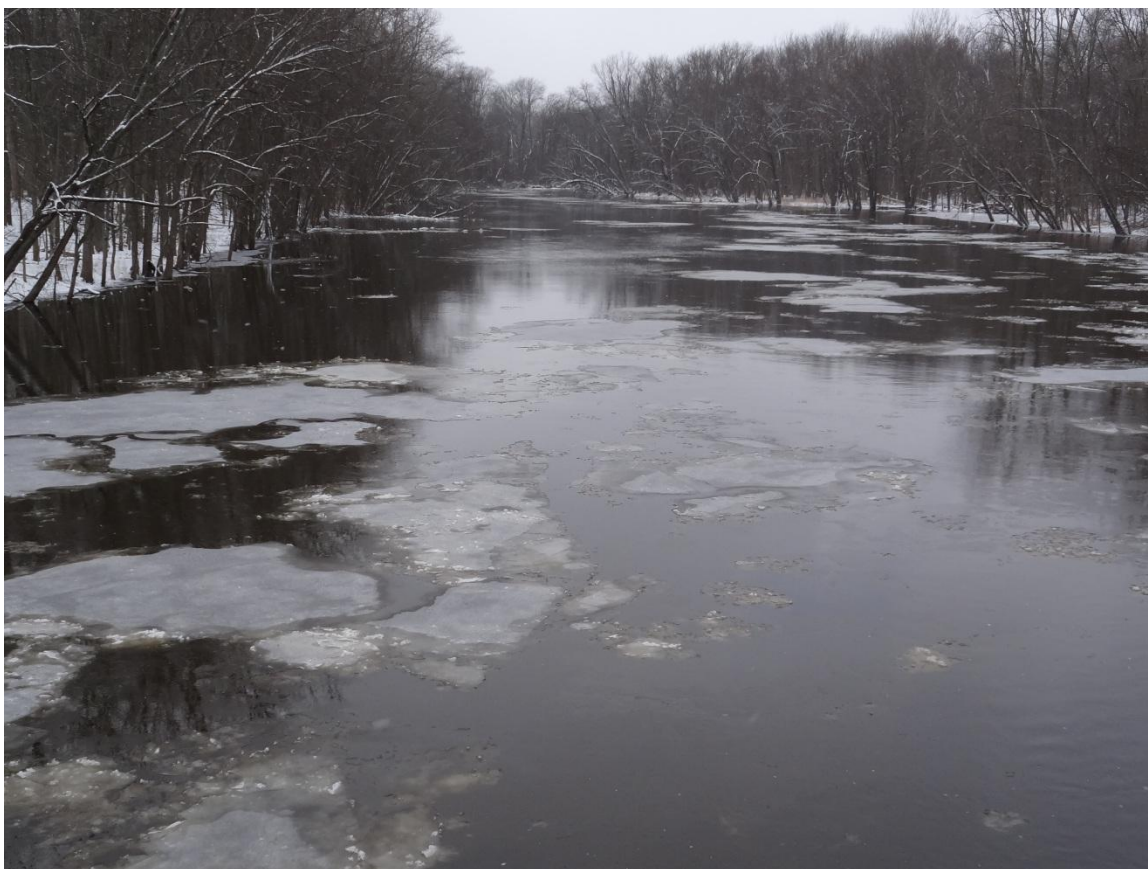
12. MP21.50 observed downstream river icing conditions.

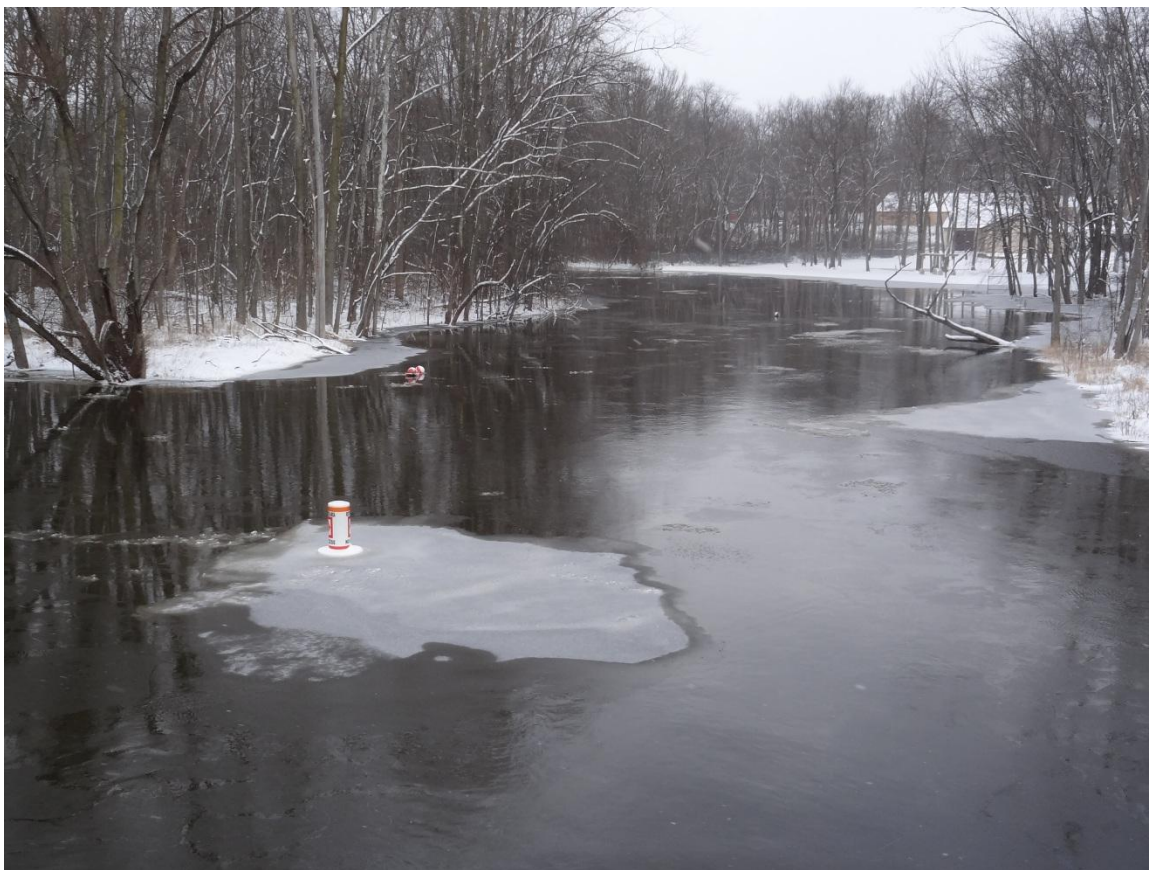
13. MP21.50 observed oxbow icing conditions.

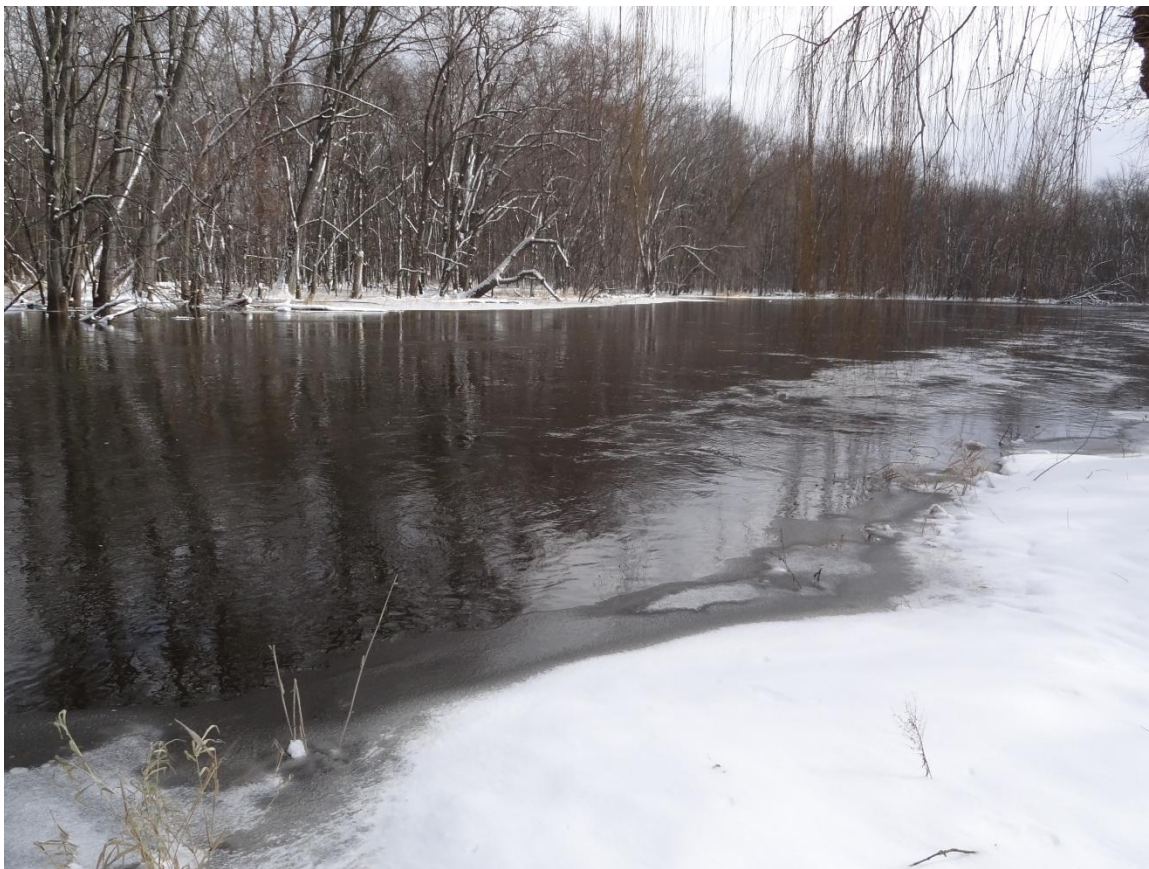
14. MP27.00 Shady Bend Campground observed river icing conditions.

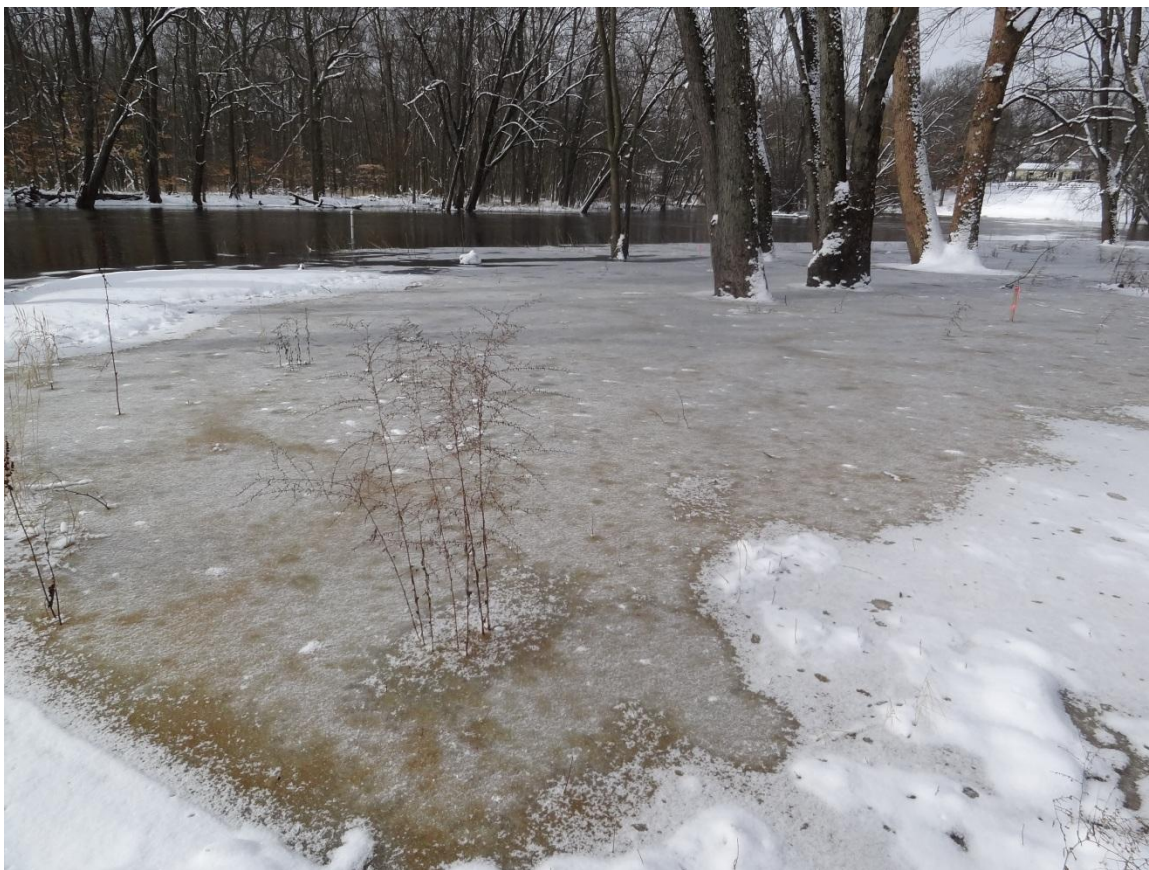
15. MP27.00 Shady Bend Campground observed river icing conditions.

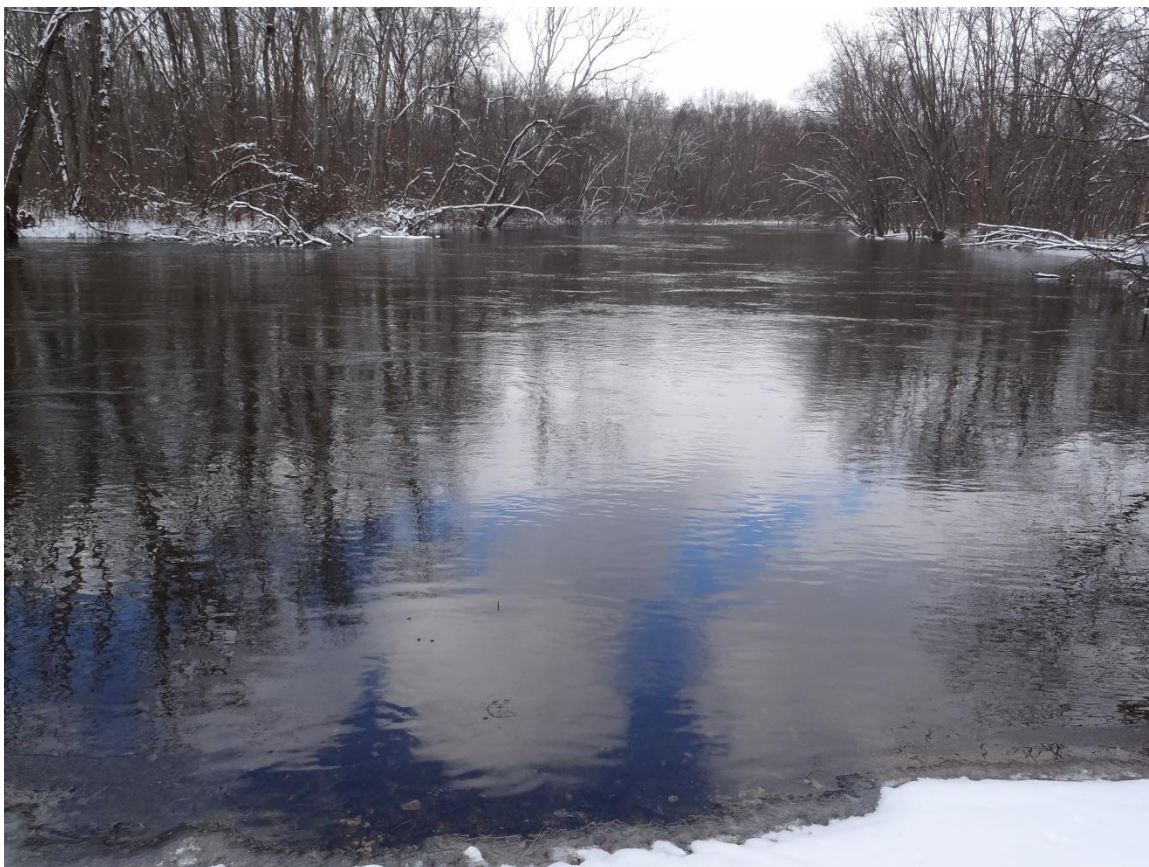
16. E2 Boat Launch observed river icing conditions.

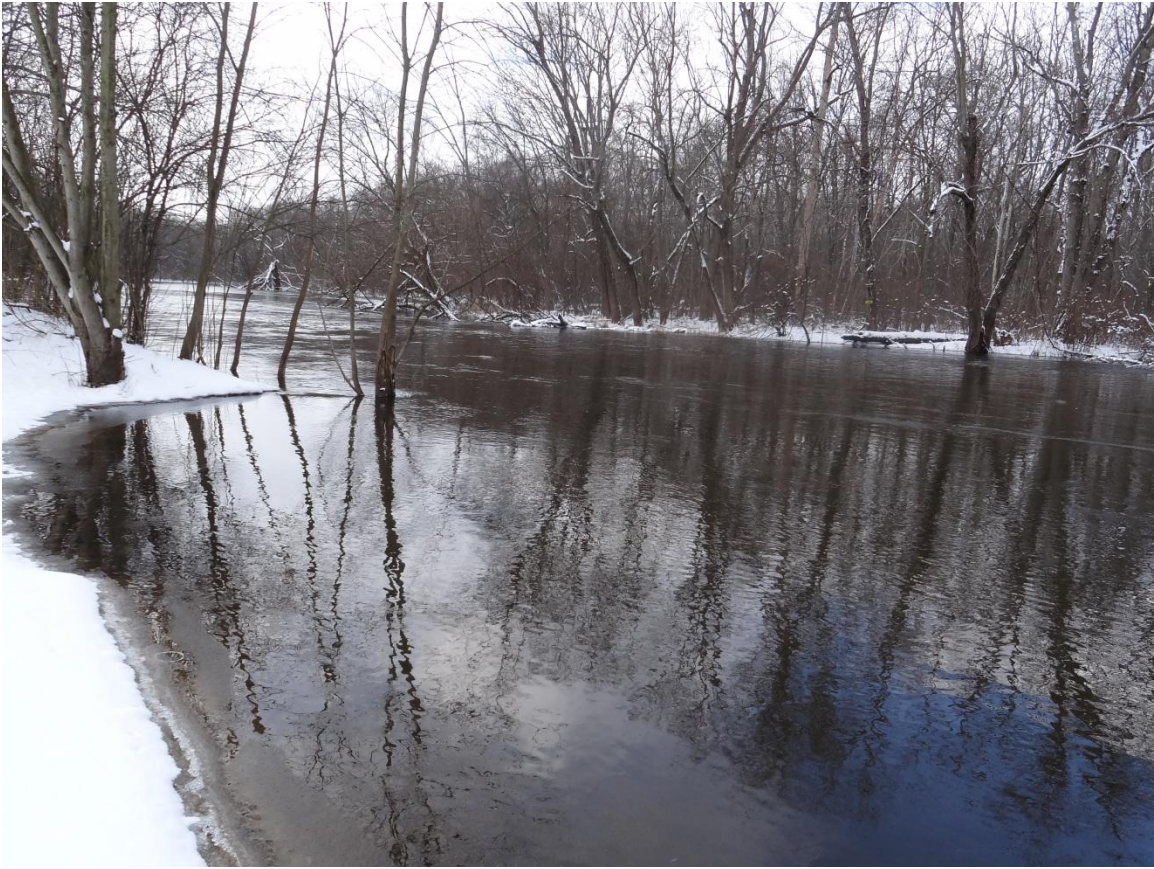
17. E2 Boat Launch observed river icing conditions.

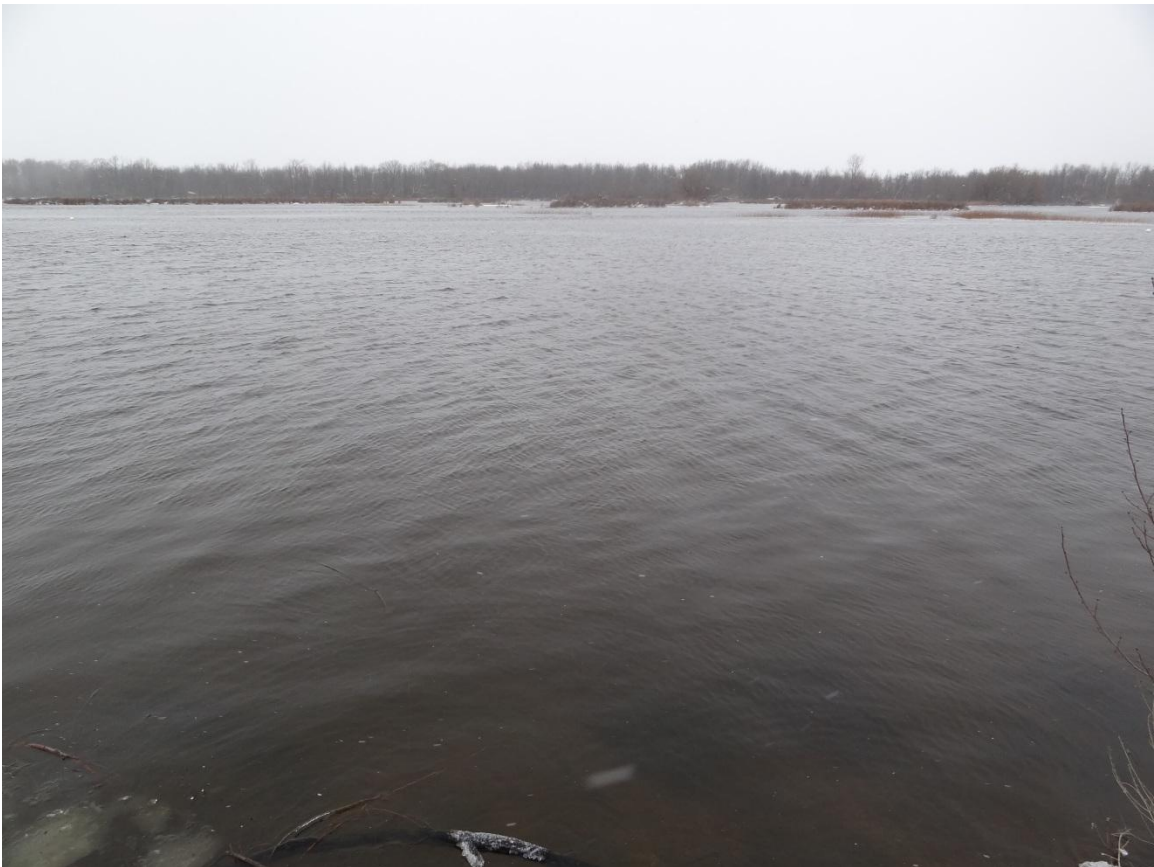
18. Morrow Lake Delta observed icing conditions.

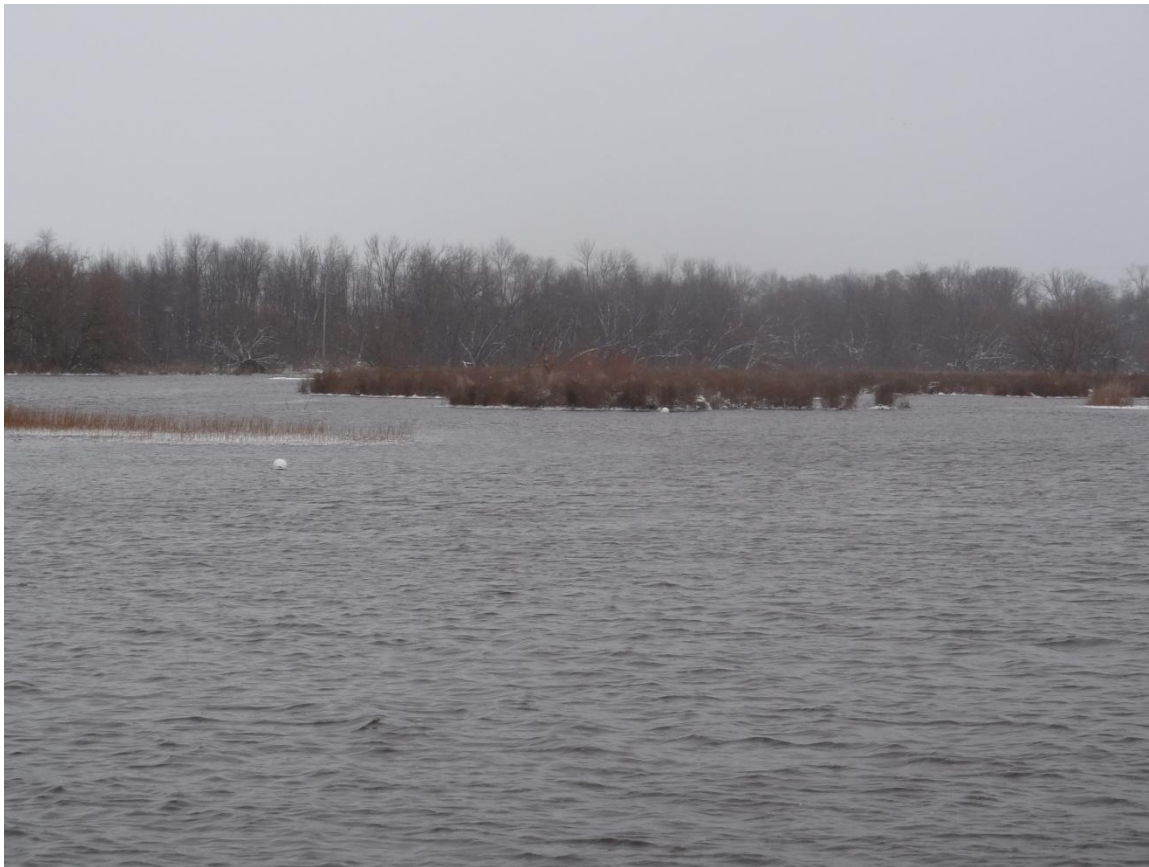
19. Morrow Lake Delta observed icing conditions.

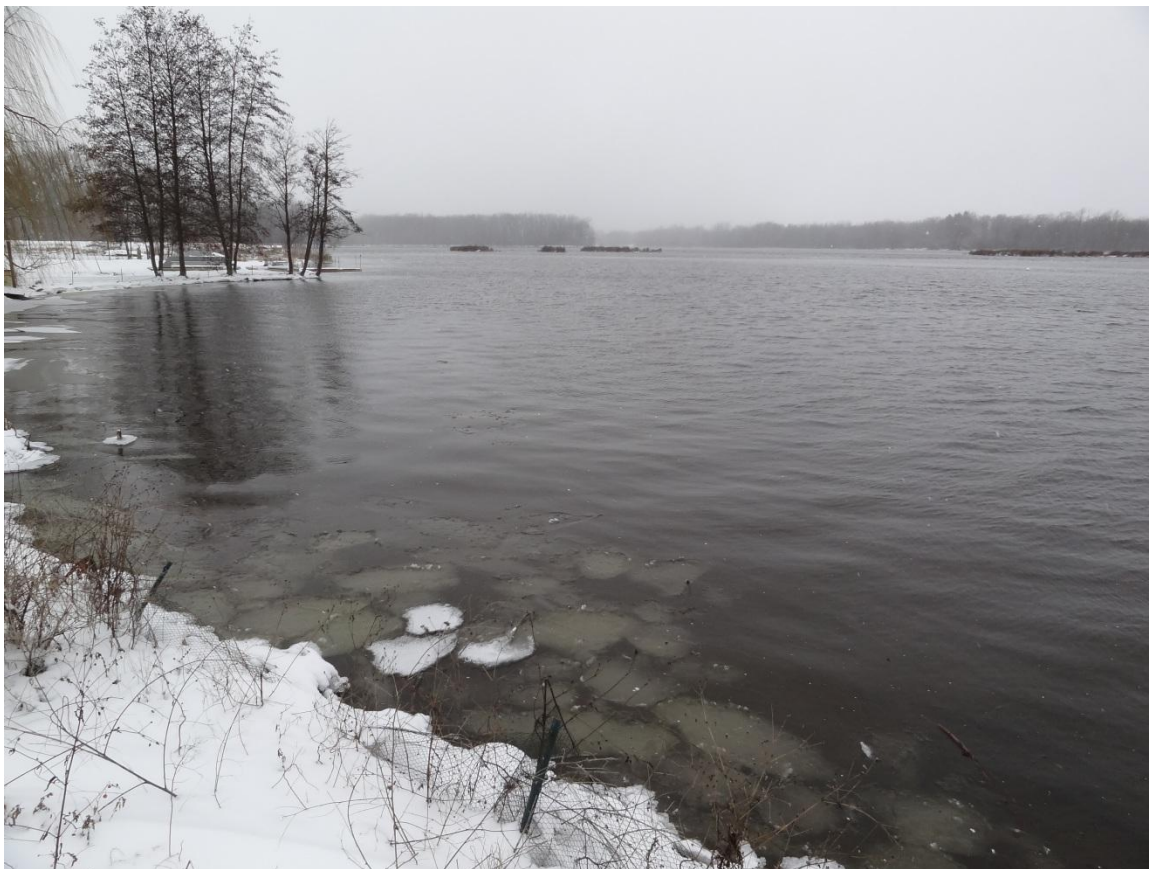
20. Morrow Lake Delta observed icing conditions.

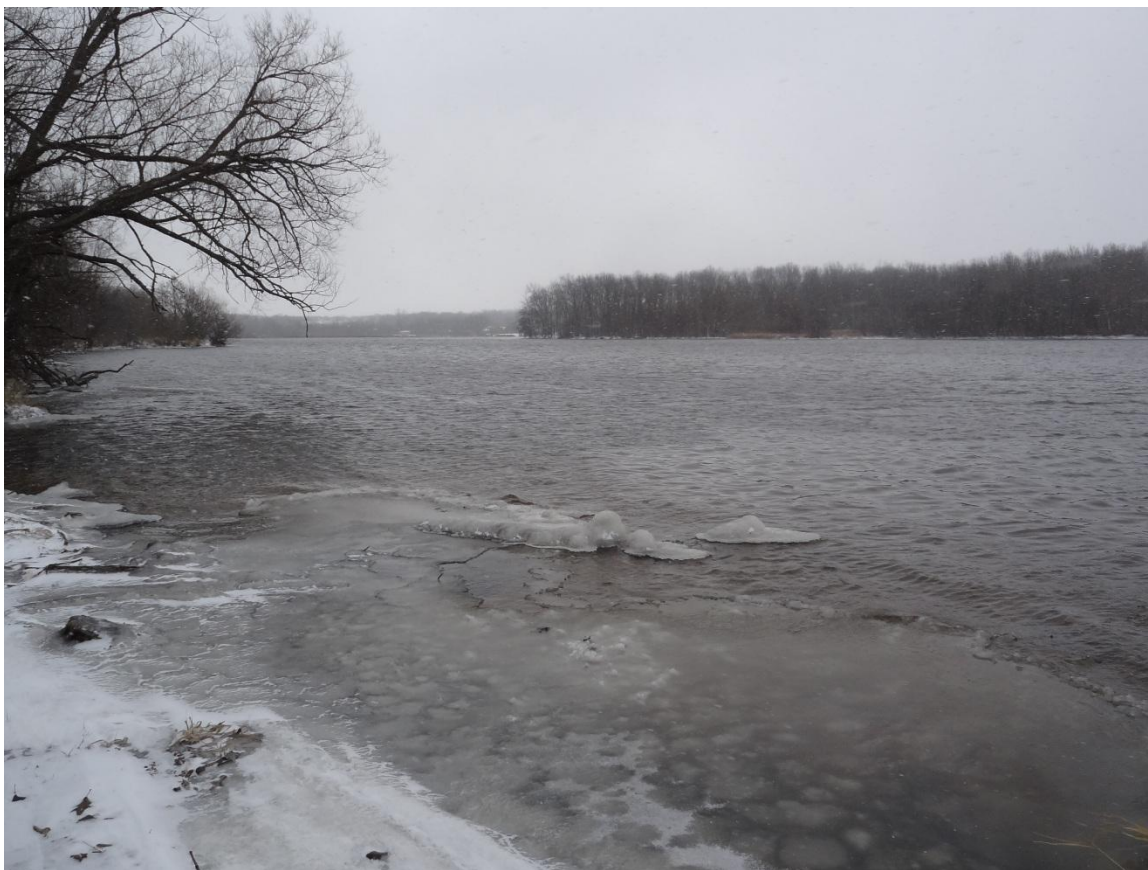
21. Morrow Lake Neck/Morrow Lake Delta observed icing conditions.

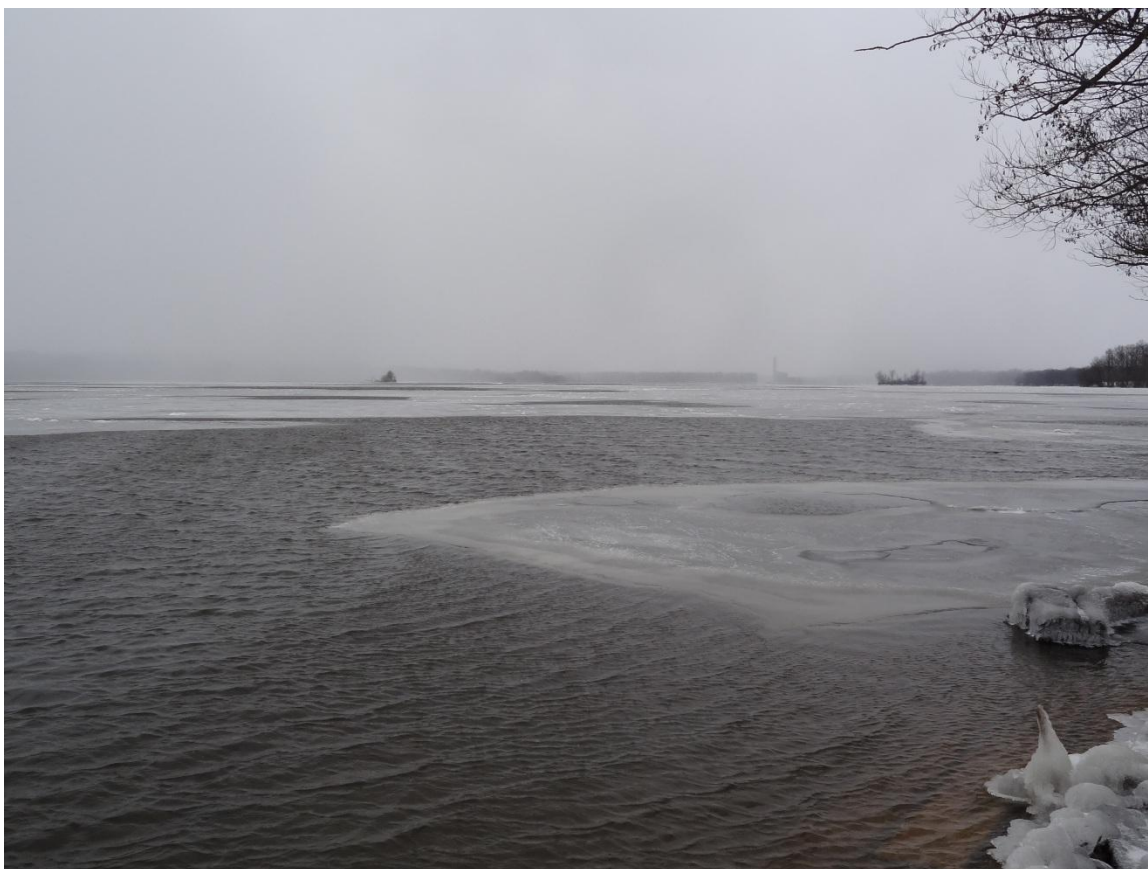
22. Morrow Lake observed icing conditions.
